# Building Assessment

## Unitarian Universalist Church of Buffalo: Interior and Exterior

695 Elmwood Ave, Buffalo, NY 14222

December 2020

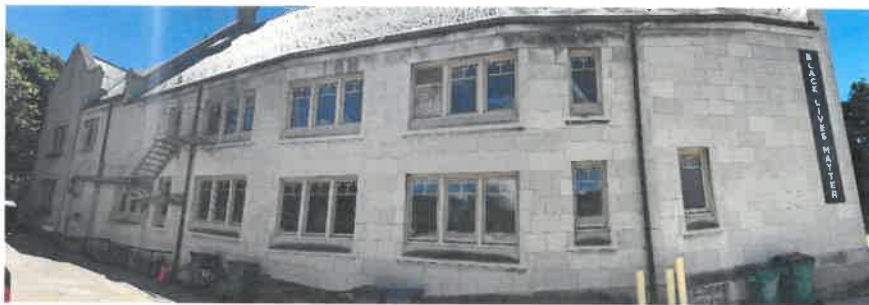
Figure 2 - North facade of the church, Elmwood Ave. is on the right.

- (1) Carbon steel dowels have been corroded and have caused jacking of the stone, opening joints for water infiltration, further exacerbating the corrosion.
  - (2) The existing copper gutters are supported by and anchored to a limestone ledge with steel pins. These pins, over time, have corroded and expanded leading to damage of the limestone façade.
- 2) See Appendix A for additional detail.

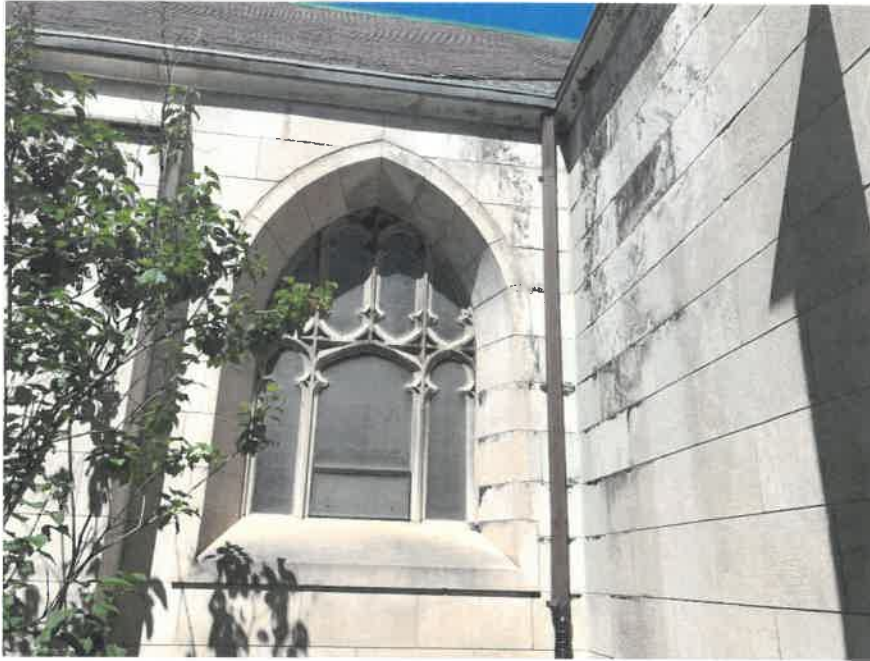
*Figure 3 View of stone gutters along East (Brittany Ln.) facade. The discoloration of the stone is likely due to corrosion of reinforcing or anchorage and water infiltration.*

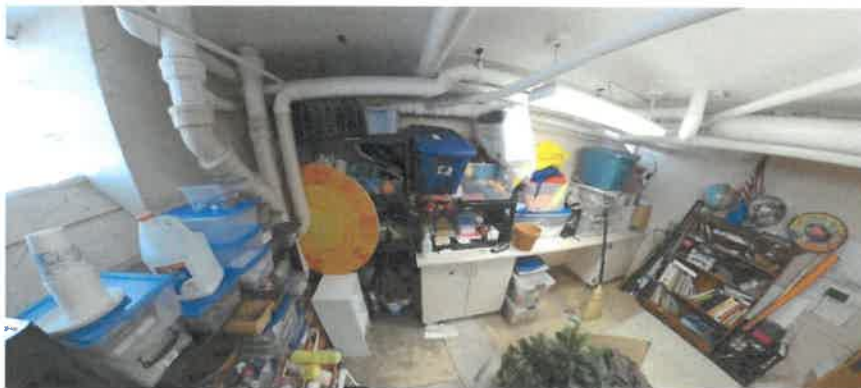
- 2) Several of the storage and classrooms on the basement level have significant water damage from this infiltration, though it is clear that the facility staff have taken measures to address this damage recently (much of the damaged VCT tile on, and the floor base has been removed). In particular, the Youth Room (Room 020) has been a long-standing, highly visible "hot button" issue for church members due to water damage and mold formation at the south and east walls. Use of the Youth Room has subsequently been prohibited due to the presence of mold and its overall deteriorated

*Figure 4- VCT tile and floor base has been removed.*

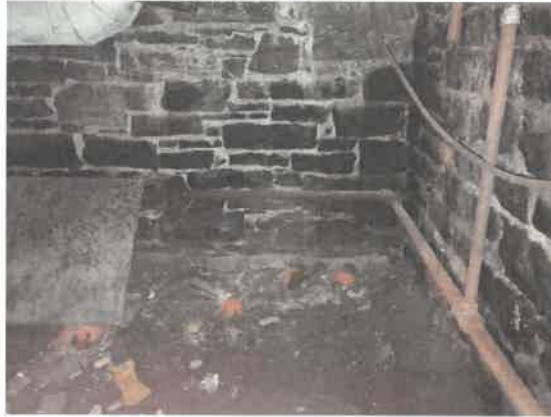
*Figure 5- Typical stone foundation- note the loose mortar present.*

- 2) The integrity of the foundation walls may be a future concern; there is loose mortar in the stone foundation and water infiltration that leads to heavy moisture presence throughout the undercroft. While the stone foundation walls are not in urgent need of repair based on Foit-Albert's assessment, if additional cracking or damage is observed, further structural investigation is recommended to see if reinforcing or re-mortaring the walls is necessary.

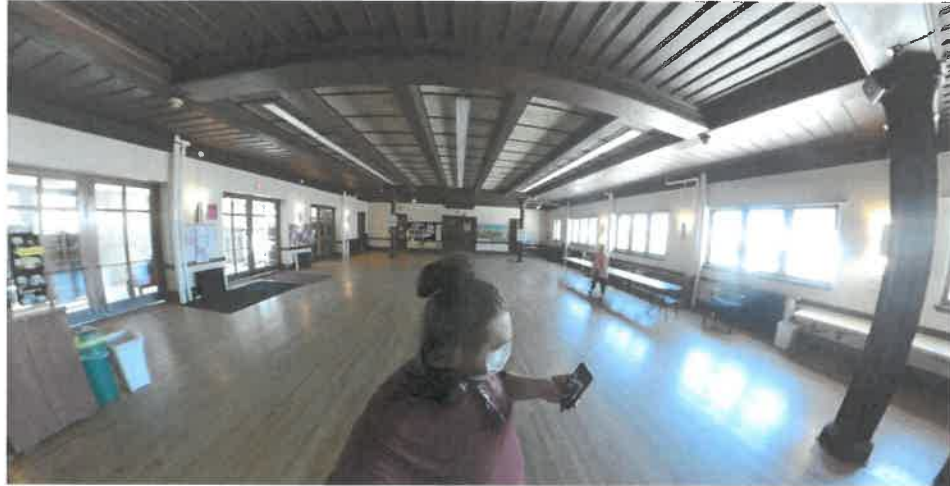
*Figure 6- The Parish Hall serves in many ways as the front facing hub of the church and has been maintained extremely well. Only minor issues were noted in the assessment.*

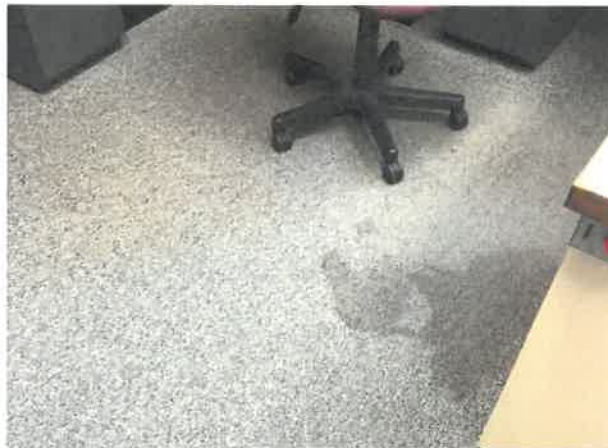
- 2) Various finishes in the semi-public offices and meeting rooms were well worn and past their useful life. These items include carpeting, wall base, and ceiling tile. The kitchen and pantry areas, while perfectly functional, are worn and should be a priority to replace (the finishes in these spaces do not significantly contribute to the

*Figure 7- Wear and tear is visible in the semi-private offices and areas of frequent staff use. These are minor issues that can either be completely ignored or addressed with replacement depending on the congregation/ committee priorities.*

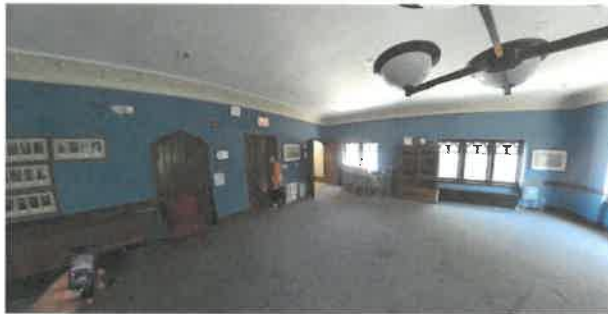
*Figure 8- Wear and tear is visible in the large meeting area on the second floor is visible on the carpet. The other finishes and assets present in the space appear to be in moderate to excellent condition.*

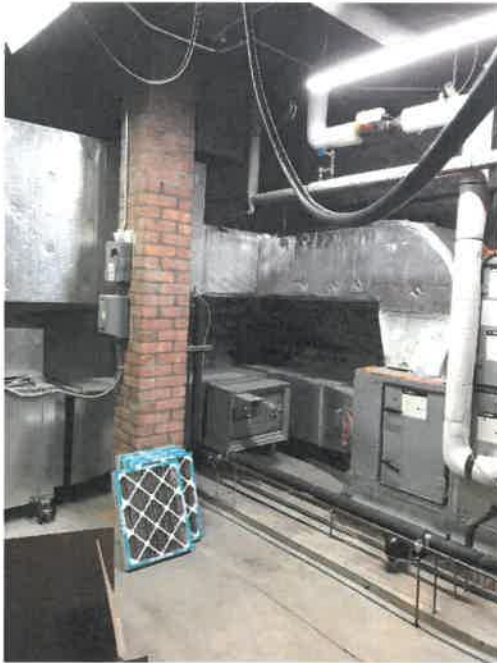
*Figure 9 - Interior Air Handling Unit*

- a. The basement office areas, library and meeting rooms are conditioned with a 20 year-old Trane HVAC/Dehumidification Air Handling Unit with steam heat and direct expansion cooling along with a ducted air distribution system. The unit has an associated 20 year-old Trane direct expansion R-22 condensing unit that is located on grade adjacent to the Facility's below grade mechanical room exterior stairwell access area (see picture below). A space sensor and return air humidistat control the systems operation. Ventilation is provided with ductwork to the air handling unit from an exterior louver within the stairwell access, referenced above. The outside air damper is operated manually and is typically in the closed position. The system reportedly performs adequately. The existing air distribution system, based upon its 20 year age, likely contains a great deal of dust and debris.

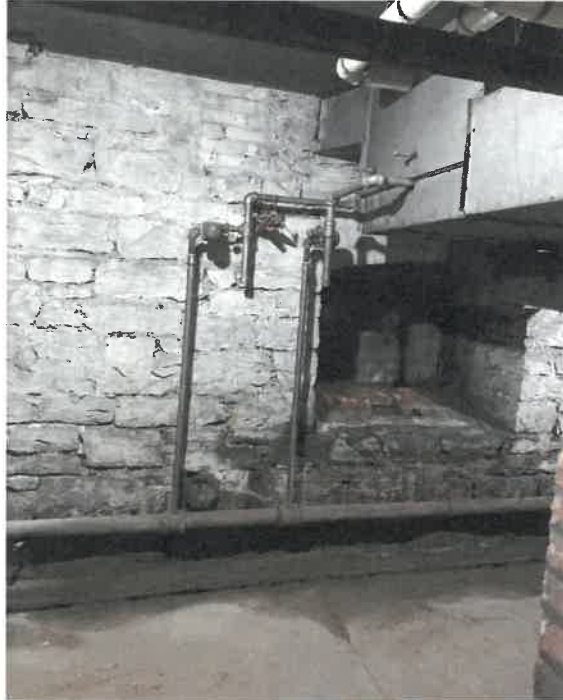
*Figure 12 - Uninsulated Steam Piping*

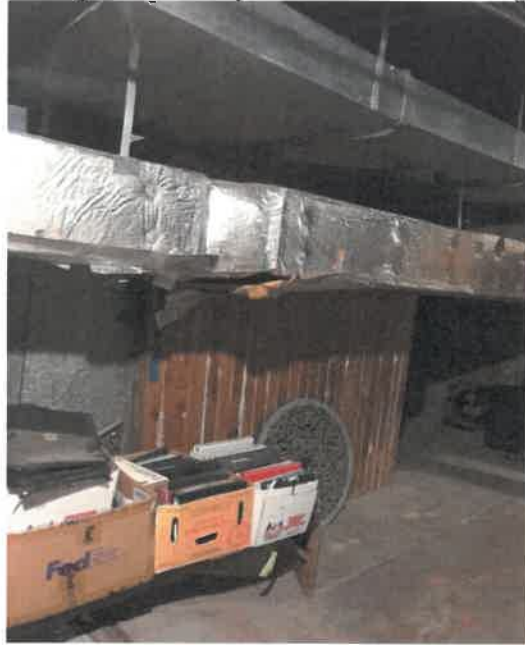
- g.** The existing condensate drain pipe supports have deteriorated and are either non-functional or missing.
- h.** The existing air distribution systems are insulated on the exterior. Repairs are required at multiple locations where damage has occurred.

*Figure 13 - Insulated Ductwork with Damaged Insulation*

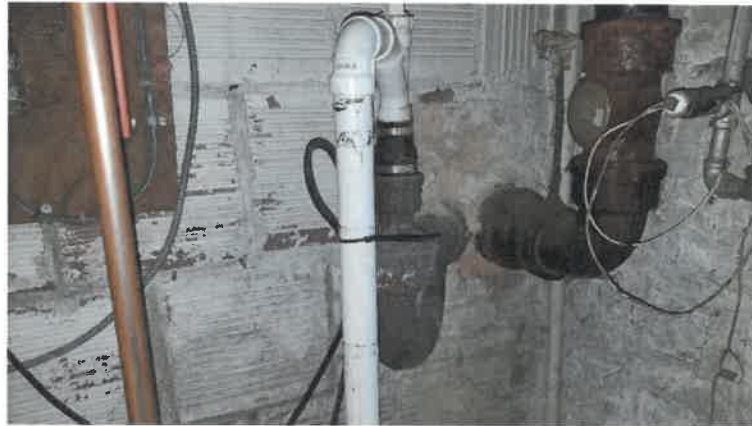
- c. Sanitary drainage conveying waste from fixtures exits the building by gravity below the basement floor. Sanitary waste and vent piping throughout the building is a combination of service weight cast iron, type DWV copper and PVC. The service weight cast iron pipe appears quite old and shows visible signs of corrosion.

*Figure 19 - Cast Iron Sanitary Waste Piping*

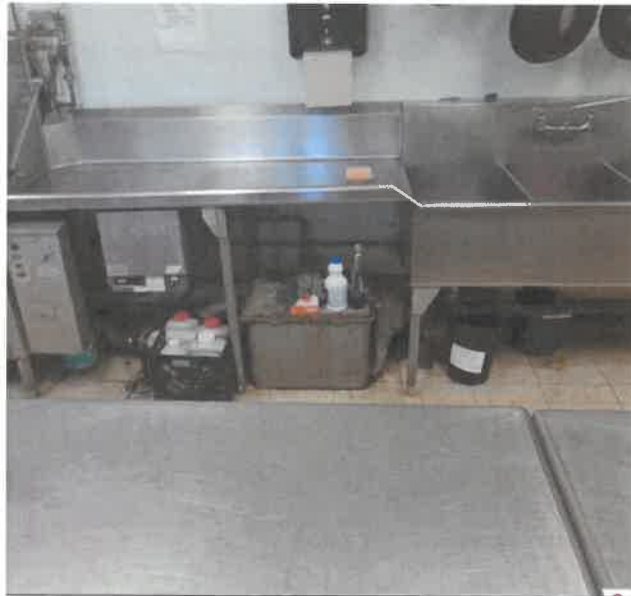
- d. The waste from the pre-rinse sink, three compartment sink and dishwasher flows through a point of use grease trap. The grease trap is an on-the-floor type. The unit appears quite old and shows visible signs of corrosion.

*Figure 20 - Kitchen Grease Trap*

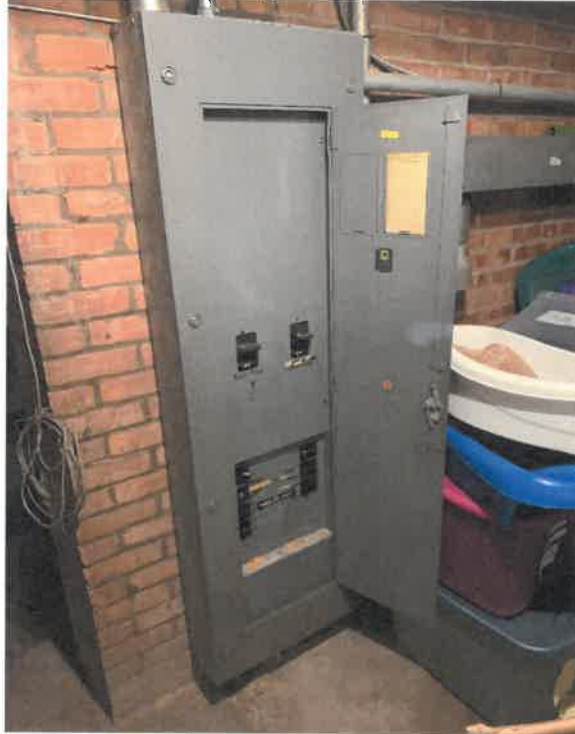
*Figure 33 - Old Main Distribution Panelboard*

- 1) "OLD MAIN DIST", located in the basement mechanical room, has reached the end of its useful life. Circuit breakers in this panel are obsolete and are no longer available from the manufacturer.

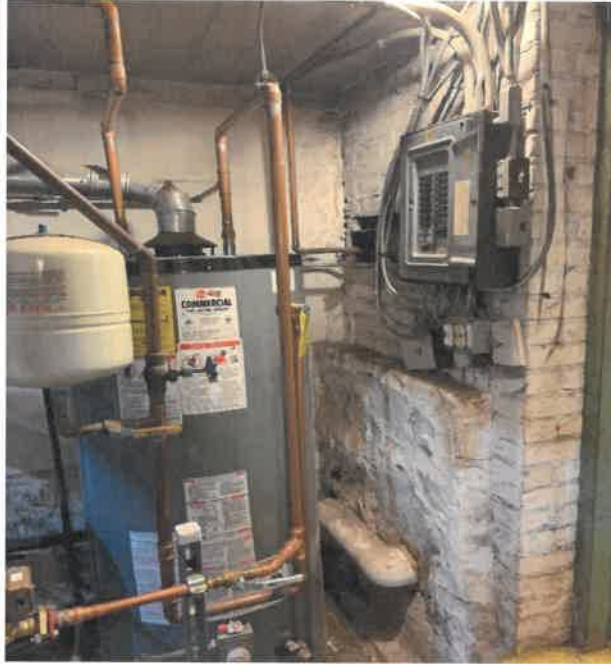
*Figure 34 - Panelboard LPBRM-1*

- 2) "LPBRM-1", located in the Boiler Room, has reached the end of its useful life, and does not have proper working clearances in front of the panelboard.

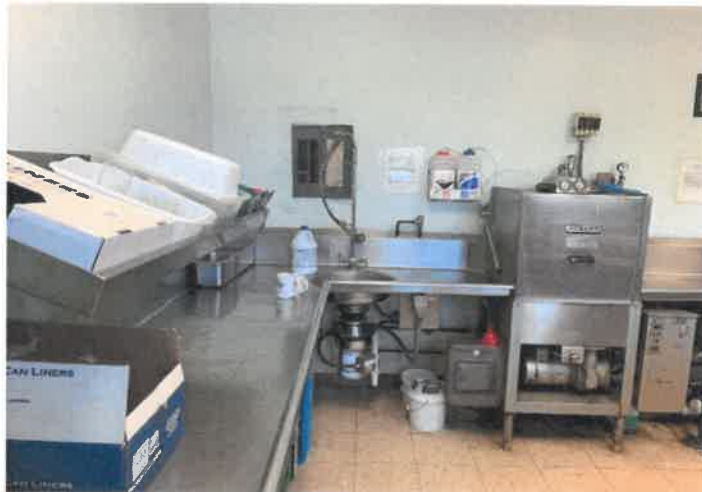
*Figure 35 - Panelboard Kitchen Panel*

- 3) "Kitchen Panel", located in the Kitchen, has reached the end of its useful life, and does not have proper working clearances in front of the panelboard.

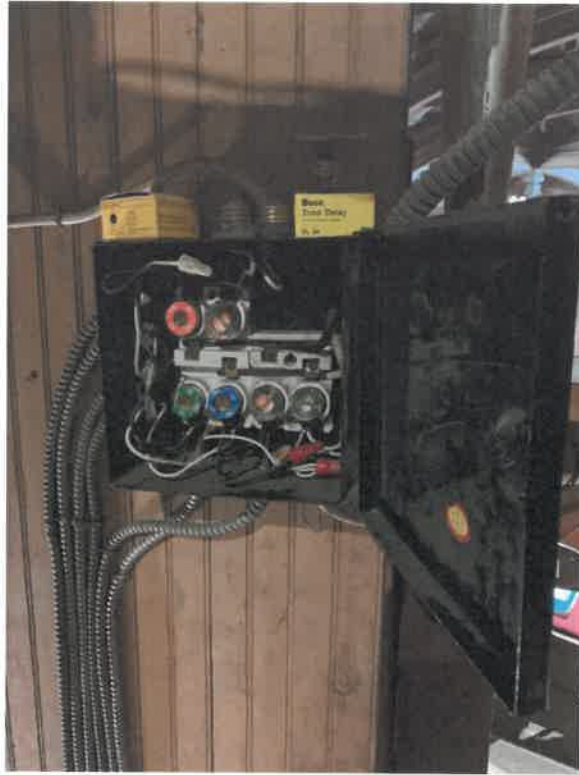
*Figure 36 - Fused Loadcenter*

- 4) The fused load center, located near the Choir Loft, has reached the end of its useful life.
