# Building Assessment

## Unitarian Universalist Church of Buffalo: Interior and Exterior

695 Elmwood Ave, Buffalo, NY 14222

December 2020

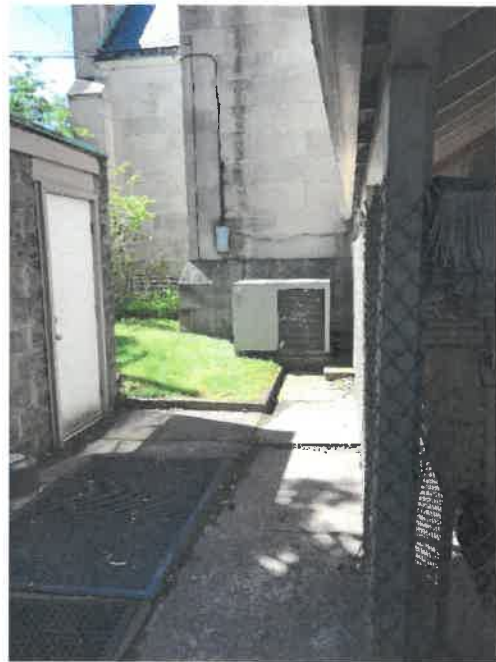
*Figure 10 - Outdoor Condensing Coil*

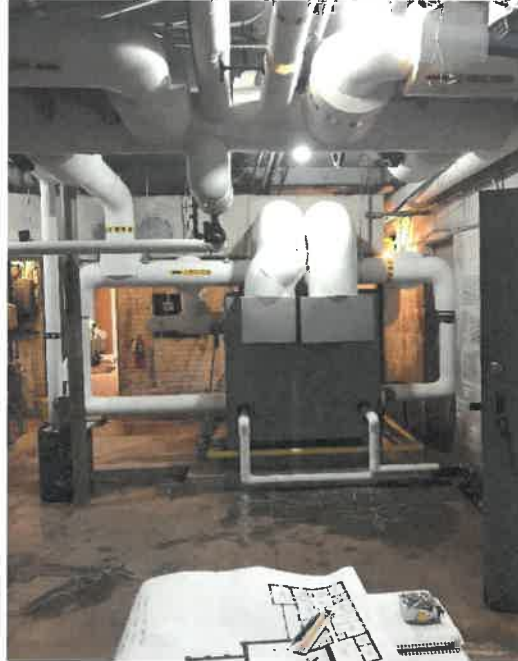
- b. The building is heated via a low pressure steam distribution system. A new low pressure steam boiler was installed in the basement mechanical room in 2015. Reportedly, the boiler performs adequately.

*Figure 11 - Steam Boiler*

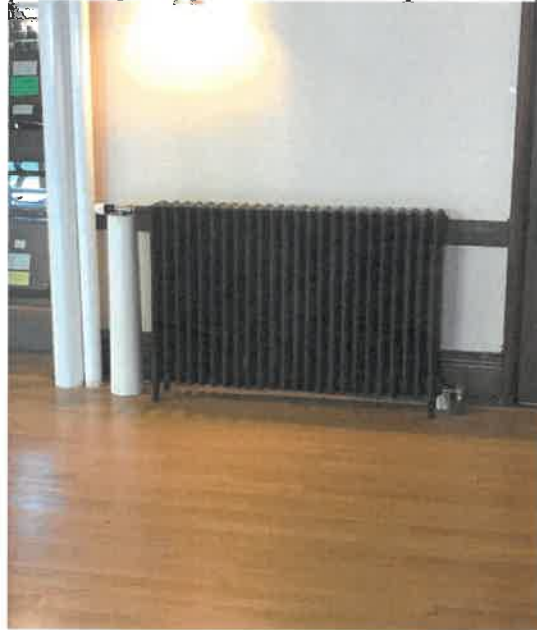
- c. Parish Hall 109 is heated with five (5) floor mounted cast iron radiators fitted with self-contained radiator control valves. Mechanical ventilation is not provided, however ventilation can be provided through the use of exterior operable windows which is permitted by Code.

*Figure 14 - Typical Radiator*

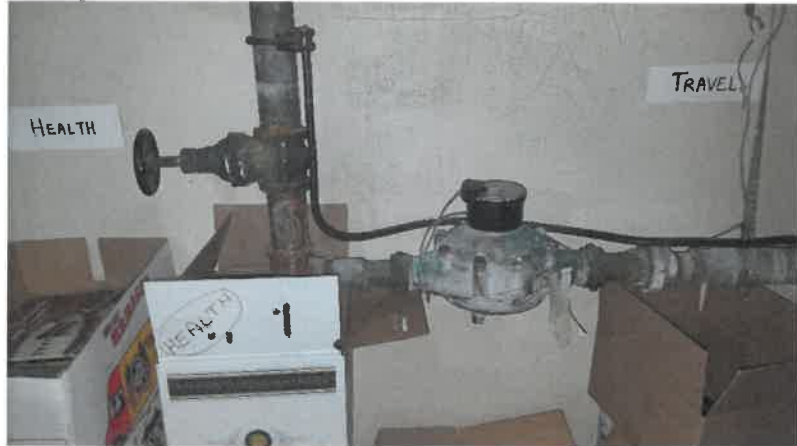
1. Domestic Cold and Hot Water Systems:
- a. Domestic cold water is supplied to the building by a 2 inch water main. No backflow prevention devices exist on this service. A backflow preventer is a device required by the City of Buffalo that is installed on the water main at the service entrance to the building that prevents backflow of water from the building into the municipal potable water supply which eliminates the risk of contaminating the municipal potable water supply. The 2 inch water main enters at the basement level in Storage Room 002. The water main decreases to 1-1/2 inch and is routed through a 1-1/2 inch water meter. From this water meter, piping is increased back to 2 inch size and is distributed throughout the building. Domestic cold water piping throughout the building is a combination of galvanized steel and copper. The galvanized piping appears quite old and shows visible signs of exterior corrosion. Corrosion is common in old steel water piping. Over time, small mounds of corrosion products (rust) form on the inside of the pipe. These mounds increase the roughness and reduce the open diameter of the inside

of the pipe thus increasing resistance to water flow. This is of little concern unless plumbing fixtures in the building are observed to have very little water pressure and flow which is not a recently reported issue at this facility.

*Figure 15 - Domestic Water Service*

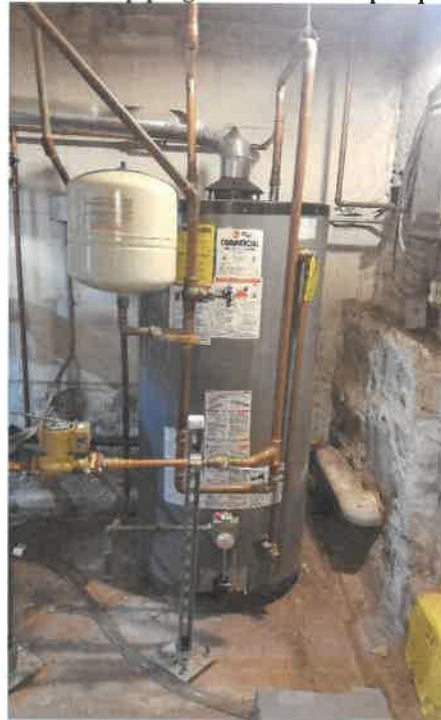
- b. Domestic hot water is generated by a gas-fired tank type water heater located within Boiler Room 009. This water heater is a draft vent type that terminates to the masonry chimney. The unit is rated for 70,000 btu/h and is equipped with 75 gallons of hot water storage capacity. The average lifespan for this style water heater is 15 years. This water heater is 2005 vintage which puts it at the end of its useful life. Hot water is distributed from this unit to plumbing fixtures throughout the building. The domestic hot water system is equipped with hot water recirculation consisting of a network of piping and circulation pump.

*Figure 16 - Domestic Water Heater*

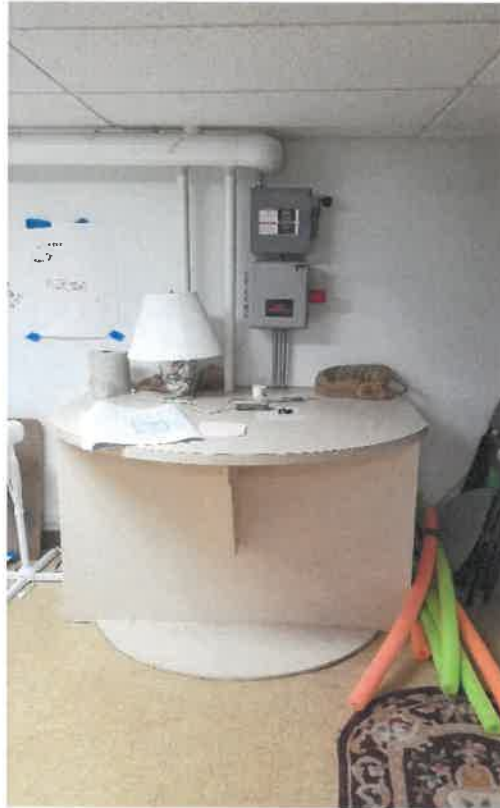
- b. The building is equipped with two (2) sump pump systems. One (1) system is located in Meeting Room 018 and consists of a duplex sump pump arrangement. The pump system is concealed behind millwork and was not observed. The intended purpose is believed to be sub-soil drainage but the design and extent of the underfloor drainage system is unknown. Another sump pump system is located in Boiler Room 009 and consists of a simplex sump pump with a backup water-powered pump. Both the primary pump and backup are manufactured by Liberty Pumps. The intended purpose is boiler condensate disposal, dehumidification condensate disposal, disposal of water from Undercroft foundation drainage system and drainage of water from exterior stairwell to the boiler room.

Figure 17 - Meeting Room 018 Sump Pump System

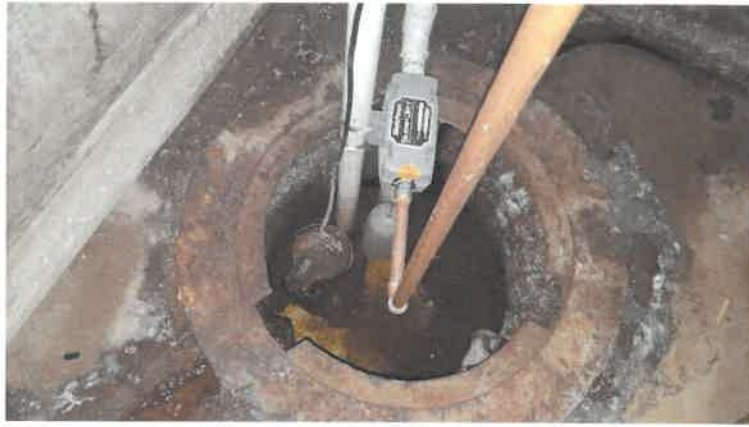
*Figure 18 - Boiler Room 009 Sump Pump System*

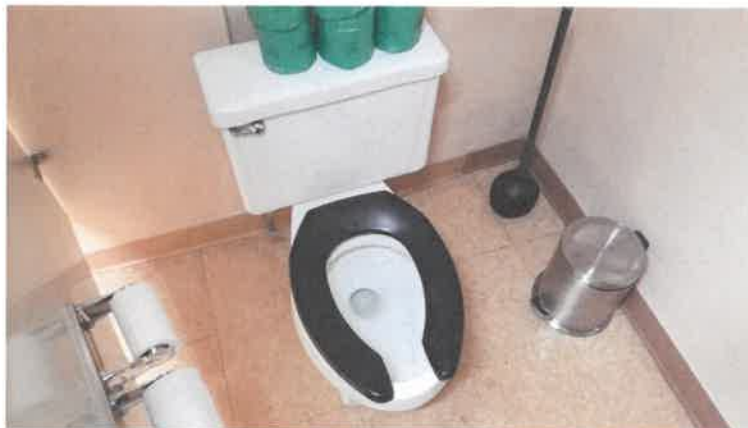
- a. There is a toilet room in the basement that is equipped with a water closet and two (2) lavatories. The water closet was replaced in august of 2020. There is signage above the water closet indicating it has been problematic in the past. The lavatories are self-rimming countertop type with manual metering faucets and appear in good condition. It is evident there were two urinals in this toilet room but have since been removed.

*Figure 21 - Basement Water Closet*

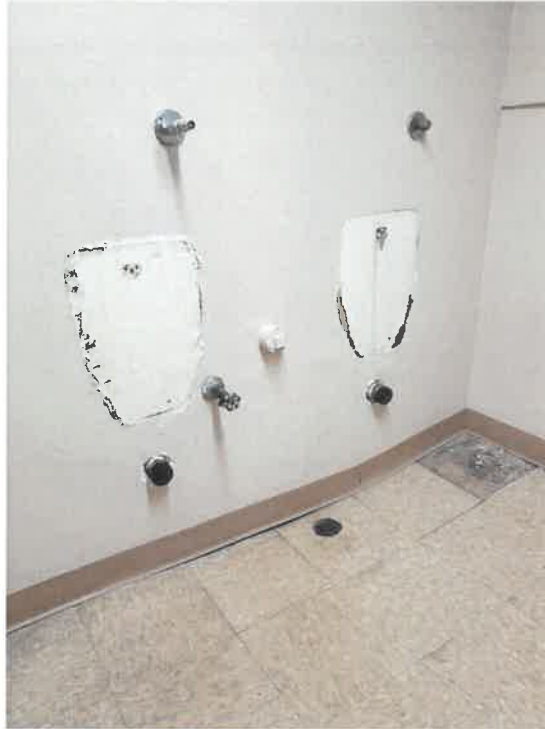
*Figure 22 – Location of former Basement Urinal (since removed)*

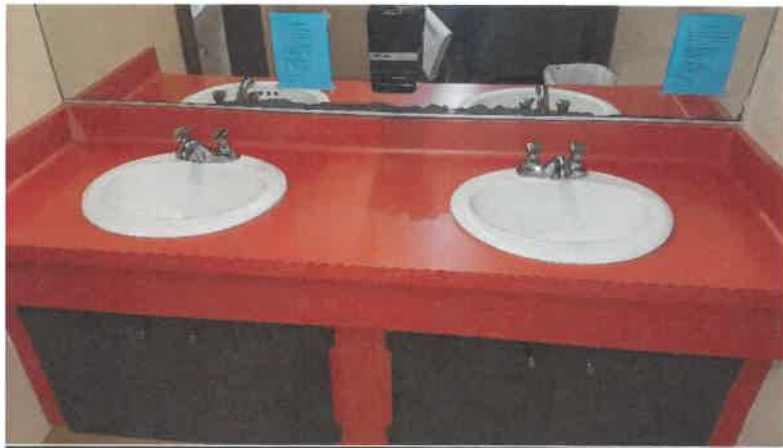
*Figure 23 - Basement Lavatories*

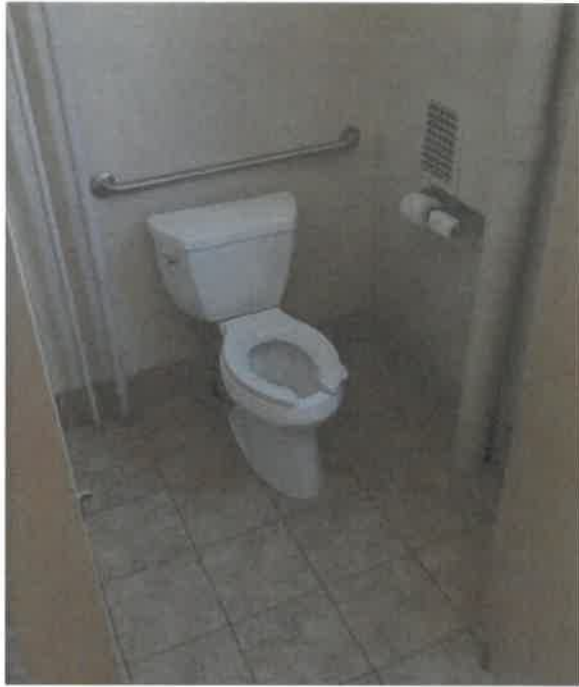
- b. There is a men's toilet room on the first floor that is equipped with a water closet, lavatories. The water closet is a floor mount tank type that appears in good condition. The urinals are wall hung with flushometers and appear in good condition. The lavatories are self-rimming countertop type with manual metering faucets and appear in good condition.

*Figure 24 - Men's Water Closet*

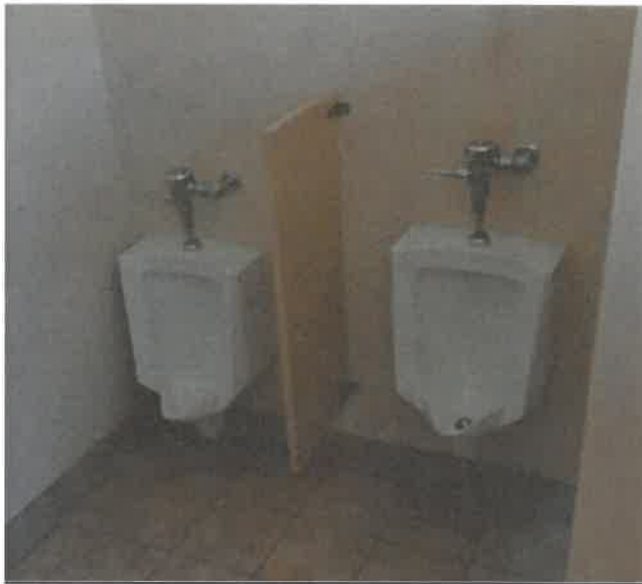
*Figure 25 - Men's Urinal*

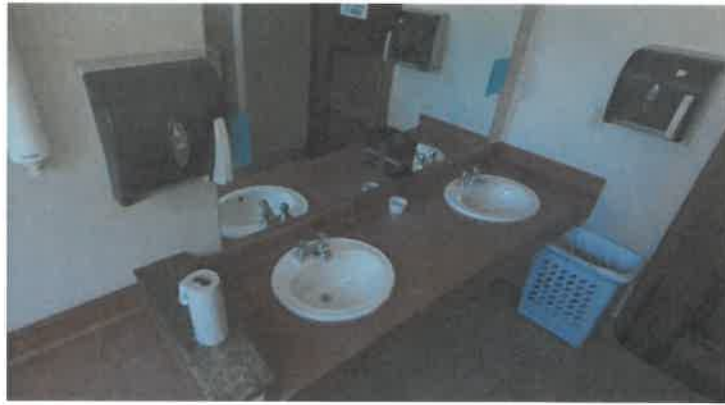
*Figure 26 - Men's Lavatories*

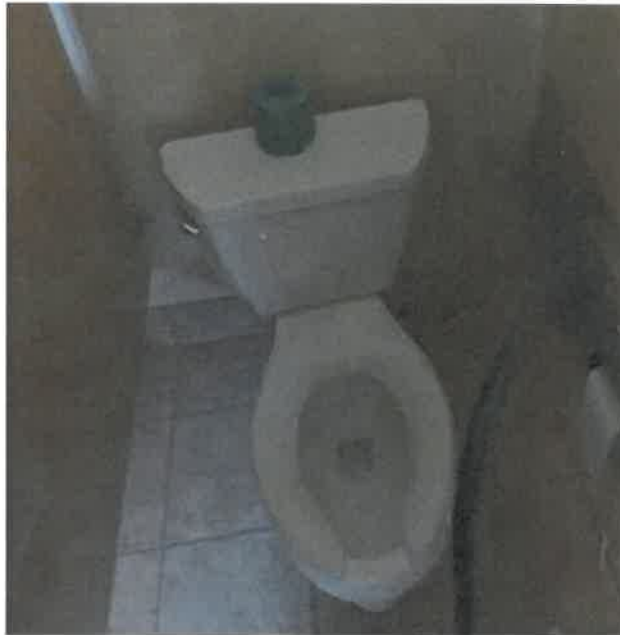
- c. There is a women's toilet room on the first floor that is equipped with water closets and lavatories. The water closets are floor mount tank type that appear in good condition. The lavatories are self-rimming countertop type with manual metering faucets and appear in good condition.

*Figure 27 - Women's Water Closet*

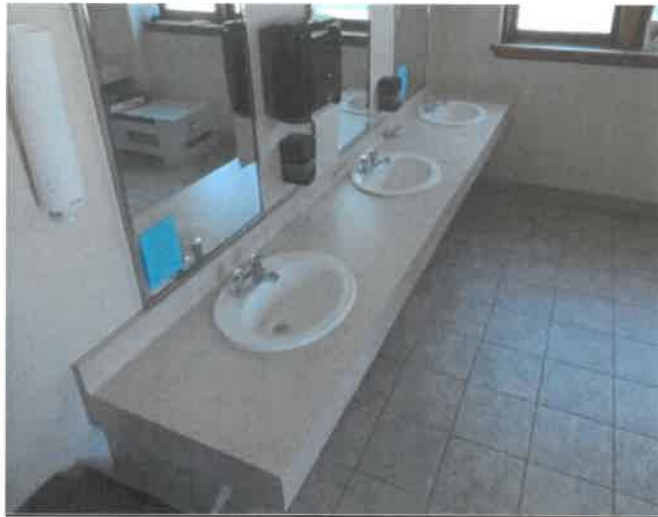
*Figure 28 - Women's Lavatories*

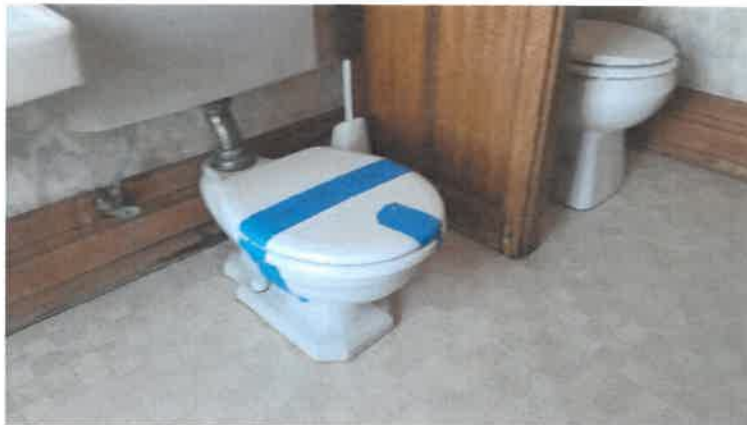
- d. There is a toilet room on the second floor that is equipped with two (2) water closet and two (2) lavatories. The water closets are floor mount tank type in which one (1) appears quite old. There is signage on one (1) water closet indicating it has been problematic in the past. Staff report this water closet has been problematic from a long time. The lavatories are wall hung type with manual metering faucets and appear in fair condition

*Figure 29 - Second Floor Water Closet*

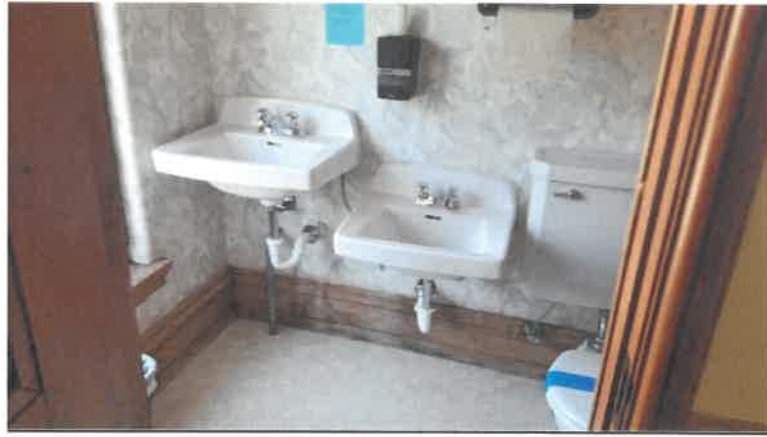
*Figure 30 - Second Floor Lavatories*

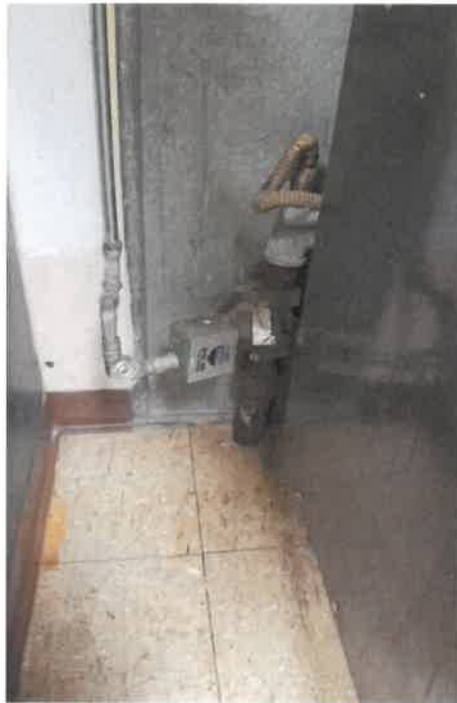
- a. The gas meter is located outside the building. Natural gas piping is routed through the building to supply the boiler, water heater and kitchen equipment. The gas supply to kitchen equipment is equipped with an emergency shut-off valve that is interfaced with the hood suppression system. This system is required to be tested and certified on a regular basis.

*Figure 31 - Kitchen Gas Emergency Shutoff Valve*

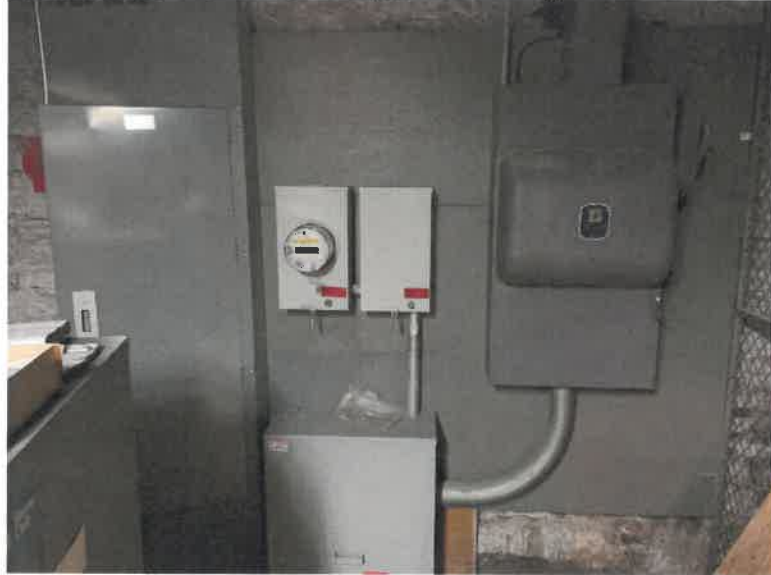
- a. The aerial electrical service to the facility is located on the east side of the building and is provided by National Grid. The service is 400 amps, 208/120 volt, three phase, and feeds a distribution switchboard via service safety switch and utility metering all of which is located in the western portion of the Basement. The main distribution panel "MDP" was installed approximately 20 years ago and appears to be in good condition.

*Figure 32 - MDP, Utility Meter and Service Disconnect*

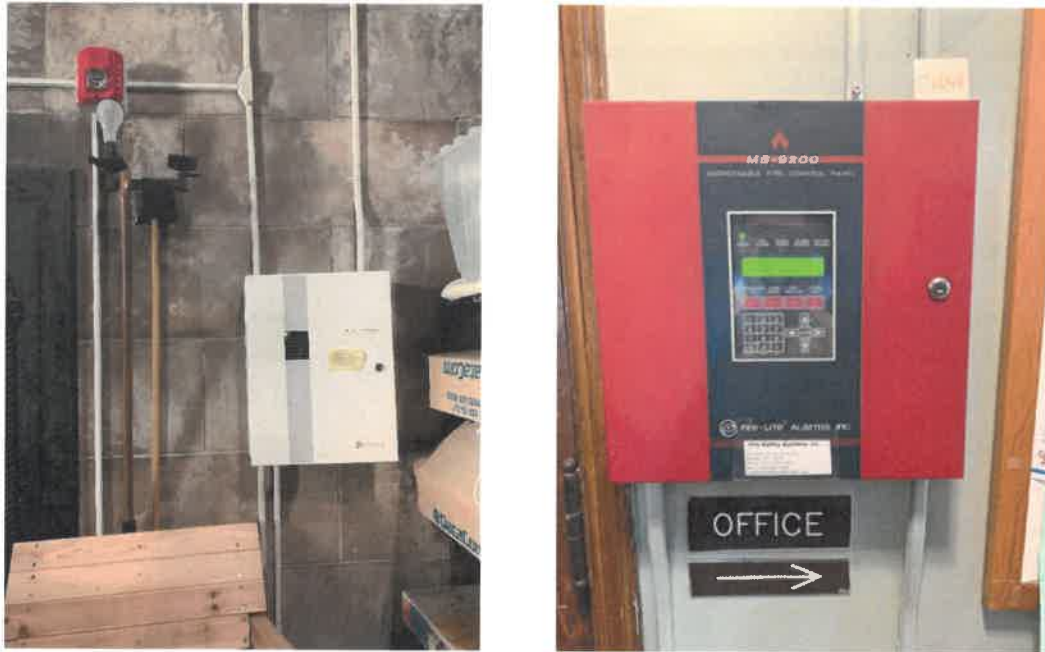
- c. Beam type detectors provide coverage for the sanctuary.
- d. Notification appliances appear to be installed in all public egress paths with the exception of the Sanctuary. Although most may be functional, most devices are showing their age and are approaching the end of their useful life expectancy.

*Figure 37 - Existing Fire Alarm Control Panels*

- e. There are several battery operated stand-alone carbon monoxide (CO) detectors installed in the basement first and second floors. Detectors should be placed at the source of all CO producing equipment, i.e. Boiler Room, Kitchen etc. Refer to recommendations for integration of CO detection and notification into the fire alarm system.
